Revista Brasileira de Geomorfologia

v. 23, n° 3 (2022)

The Study of Anthropogenic Disturbance on Geopedogenetic Process at the Lower Slope of Mt. Ungaran, Indonesia

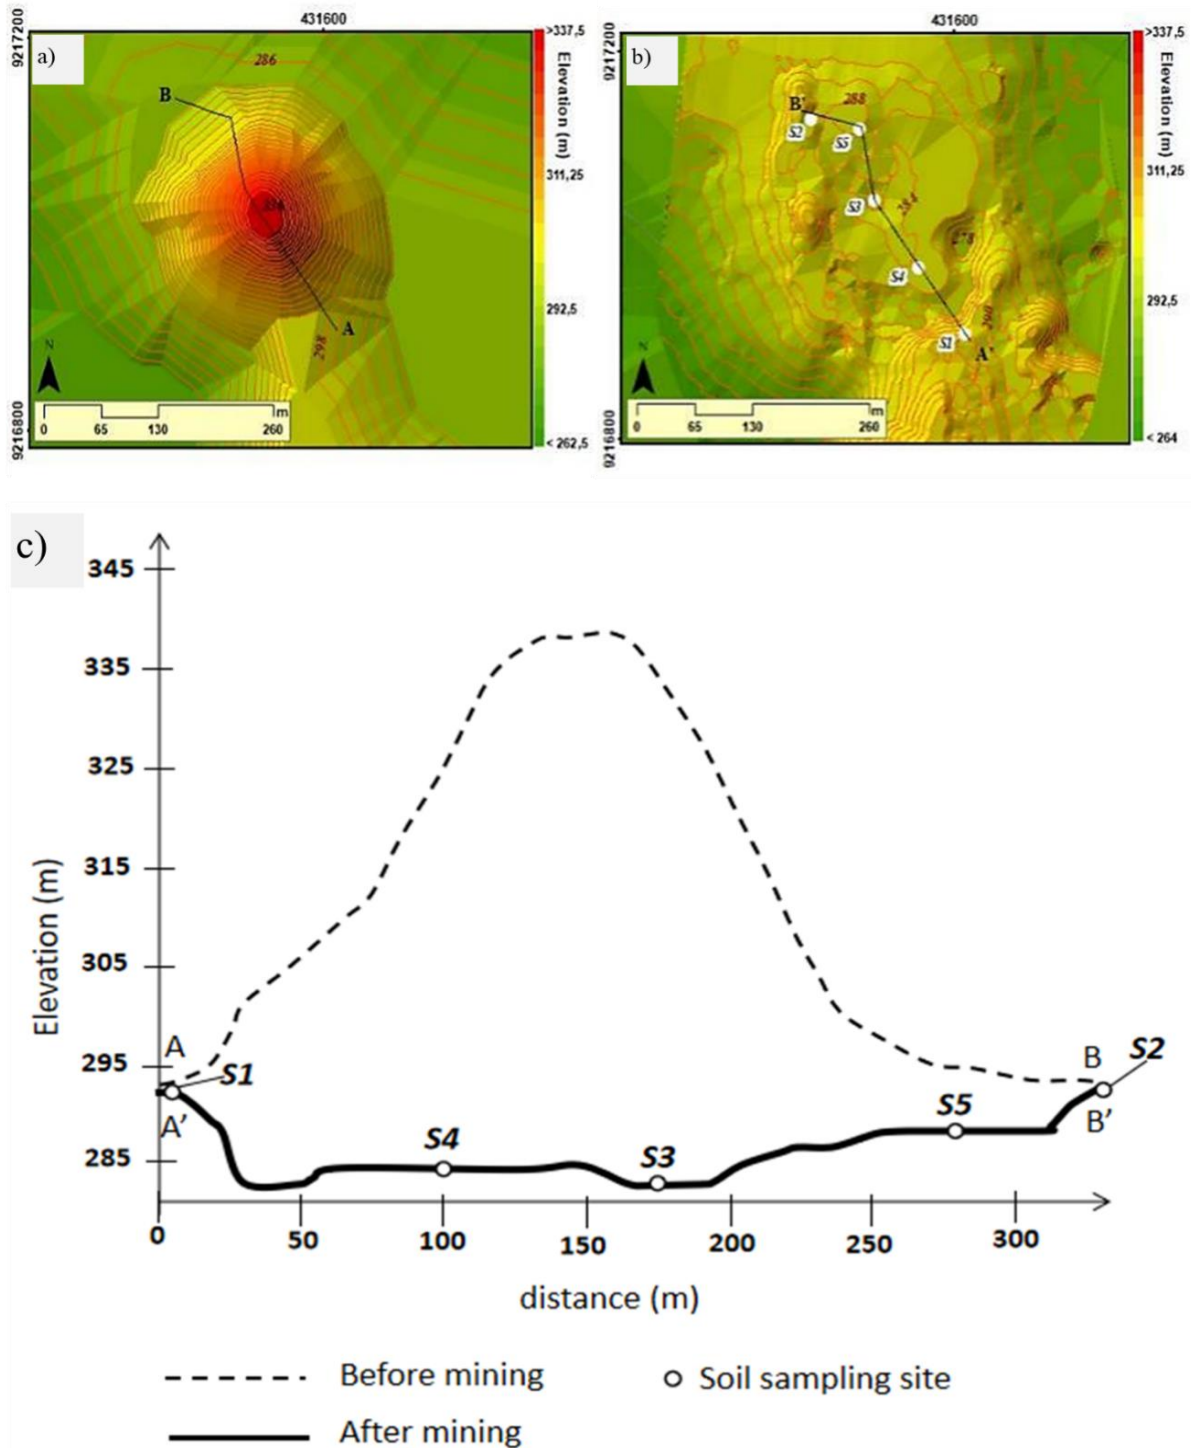
Figure 2. Impact of mining activity on morphological change. a) Morphological form before mining. b) Morphological form after mining. c) Morphological cross-section before and after mining.

The integrated method has satisfactorily produced a more comprehensive analysis of the pedogeomorphological process changes due to human disturbance in a mining area. The area affected by mining activities identified from multi-temporal satellite imagery, and the newest aerial photograph generated by UAV is 12 ha. Generally, DEM analysis shows that the rock dredging process has transformed a 60 m high convex hill into an area with relatively flat morphology (Fig 2). On a more detailed scale, five zones are identified as affected areas from a series of mining processes, which are then predicted to have significant changes in geomorphological and pedological processes. The five zones are (i) highwall zone, (ii) cutbanks zone (iii) drainage pits zone, (iv) reclamation zone, and (v) scalped zone.

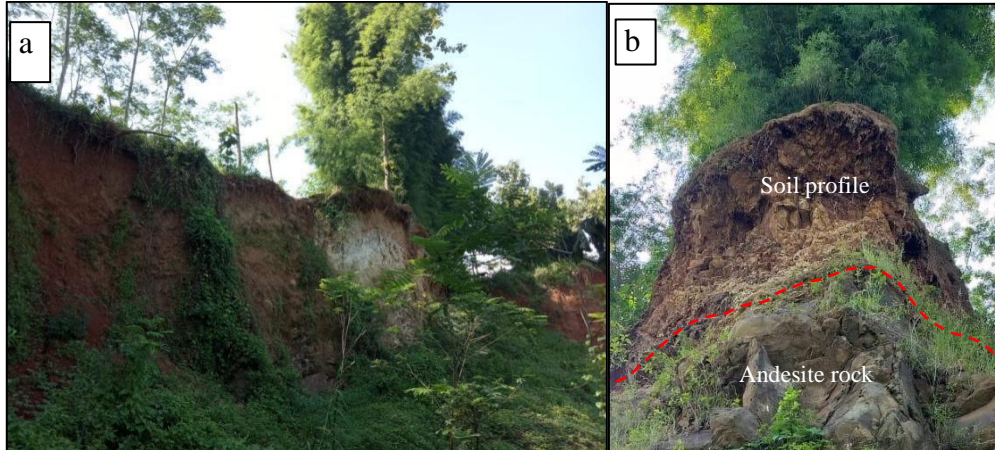
Figure 3. a) A steep slope along the highwall on the outer zone of the mining area. b) the outcrop showing the original soil developed from andesite rock.

The Highwall zone is a cliff as high as 60 m caused by the rock dredging process. This area can be found on the outermost boundary of the west side of the mine area with a slope of almost 70 degrees (Fig 3). Along the wall, we can see the original soil profile that developed from weathered andesite rocks. The surface of the Miocene new rock has weathered and formed the parent material of the soil. Referring to the physical and chemical characteristics (see Table 1), the soil was entering its early mature stage, characterized by the formation of an A-

The steep slope in the highwall zone results in low stability to keep the slope standstill. As a result, along the highwall zone, it is prone to landslides and cliff erosion (Juhadi et al., 2020). Slope failure displaces not only the surface soil layer but also the parent material and andesite rock. Mass wasting can reduce the volume of soil significantly, while the process of cliff erosion contributes to reducing soil mass with a smaller volume but with high intensity (Passos et al., 2020). The two processes of soil and rock mass transfer will undoubtedly impact the disruption of the soil formation process in the highwall zone. Collapsed deposits consisting of a mixture of rock and soil can be found at the base of the cliff.

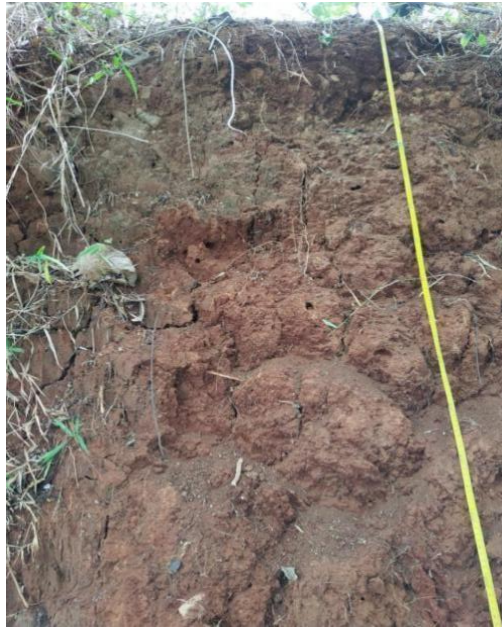
Figure 4. Soil profile exposed in the cutbanks zone of the mining area.

The dredging process of soil material on the east side left an outcrop zone of about 3 meters high (Fig 4). Soil dredging is carried out to obtain stockpile material for the main ex-mining area. On the outer boundary wall of the dredging, the original soil outcrop of development from ash and pyroclastic deposits of the Kaligetas formation can be seen.

Because the land outcrop is only about 3 meters high, the process of mass wasting does not occur in this zone. The geomorphic process observed is horizontal erosion of topsoil and vertical outcrop walls by surface water flow. However, based on visual observations, the erosion rate is not very high considering that the soil surface is well protected by various vegetation types such as sengon, durian, mahogany, banana, and grass. Except for the outcrop walls, the soil will be easily eroded because it is not covered by vegetation or grass.

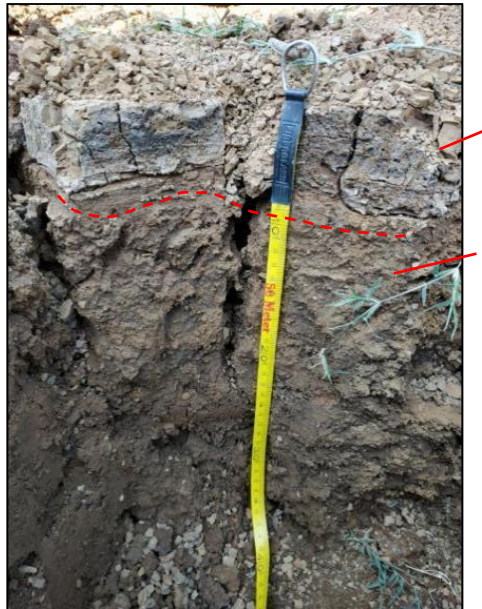
Figure 6. Sediment deposits profile showed at the drainage pit zone.

Two years after mining ended, the drainage pit zone was covered by two layers of the C horizon consisting of sedimentary deposits. Referring to the result of physical and chemical characteristics (Table 1), The first C-horizon located at the upper layer was 5 cm in thickness, yellowish-brown in color and dominated by clay particles, while the second C-horizon was 30 cm thick, with a dark yellowish-brown colour, and dominated by silt-clay particles. In dry conditions, both horizons formed a column structure with a diameter of 18 cm and a height of 34 cm. Due to its lower elevation, both layers have relatively higher soil moisture than the other zones.

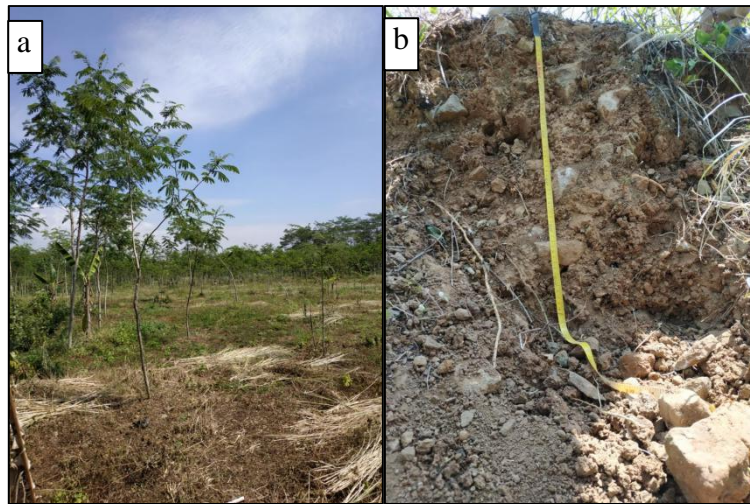
Figure 5. a) Flat morphology covered by sparse vegetation in the reclamation zone. b) Anthropogenic material containing rock and soil fragments.

Anthropogenic soil materials covered the reclamation zone around 6 m thick (Fig 5). The materials which had then become the C-horizon were composed of soil with a dark brown color and rocks with a diameter of around 3-6 cm. The soil contains a high value of silt and sands. The measured soil moisture was low at 3.6%, and the bulk density was recorded at 2.4 g/cm³. The chemical characteristics of the soil in the reclamation zone also look quite different from the original soil observed in the highwall zone. The levels of C-Organic and Total N were deficient at only 0.39% and 0.08%, respectively. However, the condition of Available Phosphate was measured to be quite high, reaching 21.67%. Base saturation is also high compared to other zones, which is 11.33, although the CEC level is only around 19.44 cmol/kg. The Exch value of cations also varies from 0.15 to 1.04 cmol/kg.

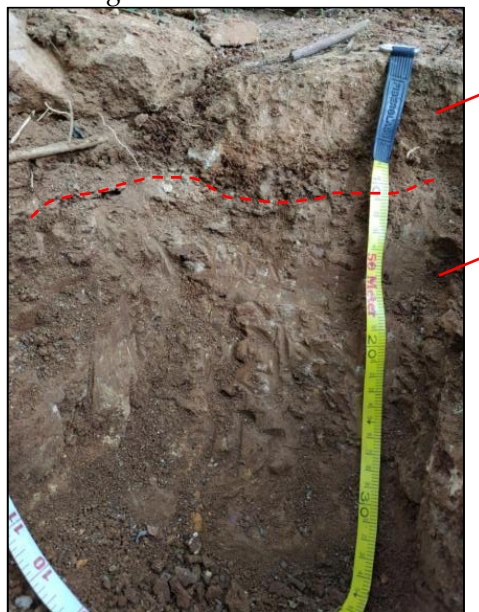
Figure 7. Soil profile showed at the scalped zone of the mining area.

The scalped zone is an area where the surface soil material has been dredged to be used as a mixture of stockpile material in the reclamation zone (Fig 7). The scalped zone is located on the northern side of the reclamation zone and has a relatively flat morphology. Shortly after the surface soil was dredged, this zone was immediately re-vegetated by planting sengon plants. The density of the vegetation is high enough that almost all of the soil surface is covered by leaf litter and grass.

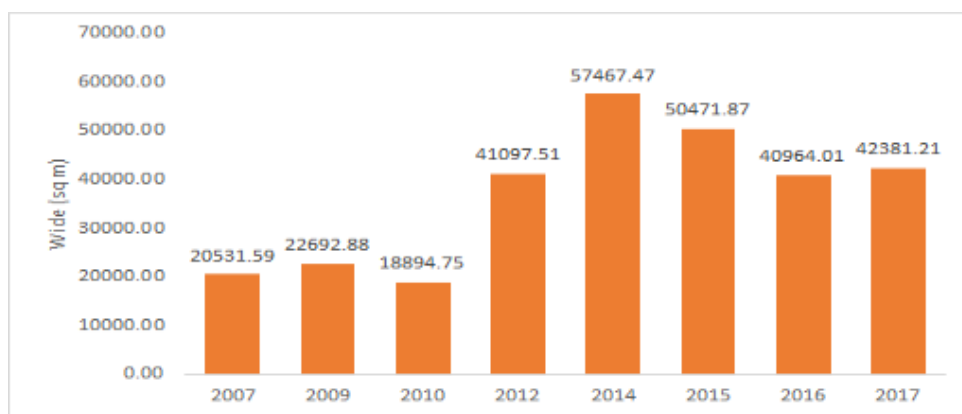
Figure 10. Changes in land clearing area (no vegetation) due to mining from 2007 to 2017. Reduced in the area indicates that revegetation has been carried out in the post-mining zone.
